**From:** Ken Nielson  
**To:** fpalacios@bbpwr.com  
**CC:** Bill Morgan; James Nelson; Jerry Finlinson  
**Date:** 12/30/2002 9:27 AM  
**Subject:** Intermountain Power. Contract 100210 - Overfire air system controls

Summary of the U1 OFA work completed by IPSC Maintenance and Rocky Mountain personnel under the direction of Phil Hailes and Ken Nielson during the 11/26/03 mini-outage. Photos showing the problems listed below are found in the following directory - **N:\Current\Projects\IGS02\IGS02-14 Boiler Modifications - JHN\6.Documentation\U1 Mini-outage Photos-Control Linkage & bearings.**

# Engineering Services Inspection Report

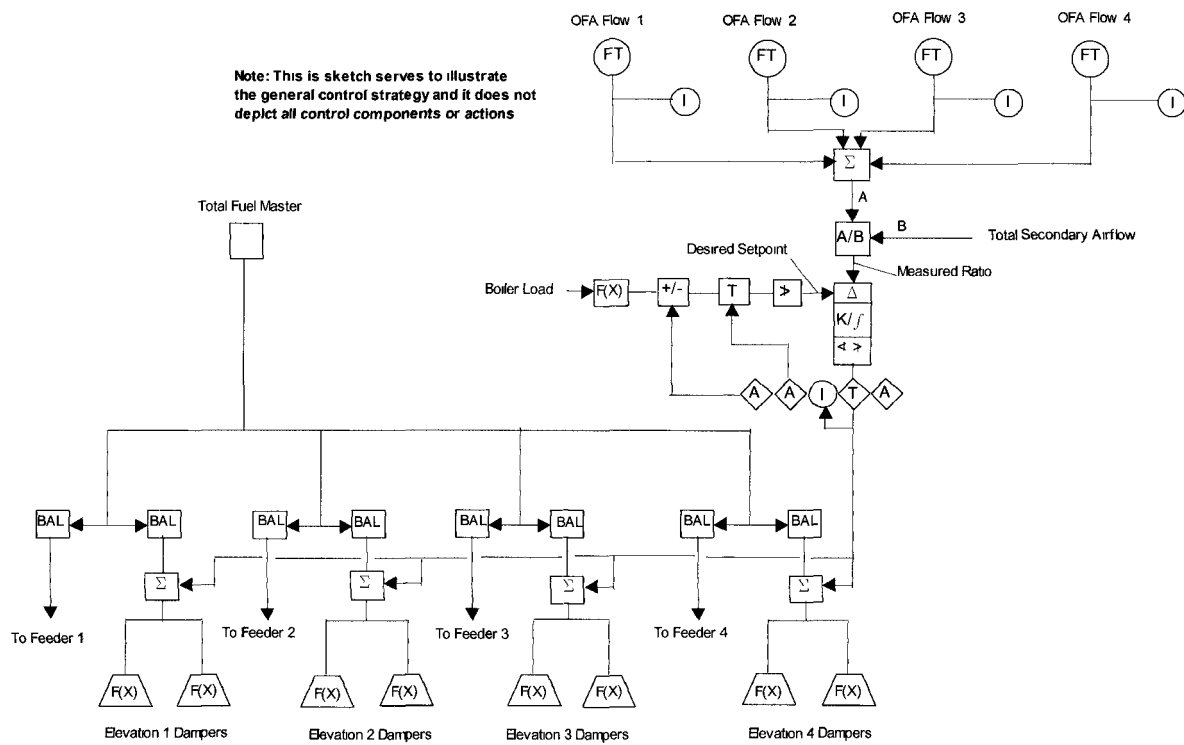
Fig 1

The OFA port relative open area sizes, 1/3 and 2/3, are calculated to provide the correct velocity of the OFA to attain the proper penetration of the OFA into the combustion region of the furnace above the burners. For this reason it is not recommended to modulate the OFA port dampers since changes in the damper position will affect the penetration velocity. All ports of a given kind: 1/3 or 2/3, will open or close following a program designed to open the correct area to roughly produce the proper penetration velocity as the OFA air flow rate changes with boiler load. The initial program is as follows:

0 to 60% boiler load:	All 1/3 and 2/3 ports closed
60 to 75% boiler load:	1/3 ports open, 2/3 ports closed
75 to 90% boiler load:	1/3 ports closed, 2/3 ports open
90 to 100% boiler load:	1/3 ports open, 2/3 ports open

An individual manual/automatic and bias station per port group damper drive is recommended.

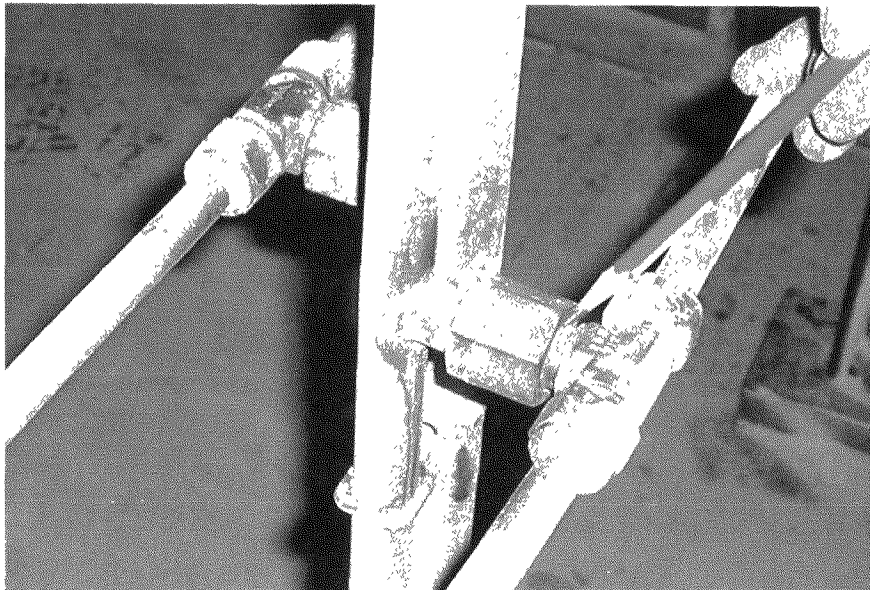
Leak check on over fire air flow meter pitots in each corner of unit. Found major leaks in the controller cabinets that were tightened.

Inside the windbox every fitting where a T is connected to the pitot has a major air leak that needs welding repair. Weld 6 fittings on the pitots in each corner of the overfired air windbox, SE, SW, NE, NW.
